Vicuna Street Northwest Site

Nowthen, Anoka County, Minnesota

Wetland Delineation Report

Kjolhaug Environmental Services Company, Inc.

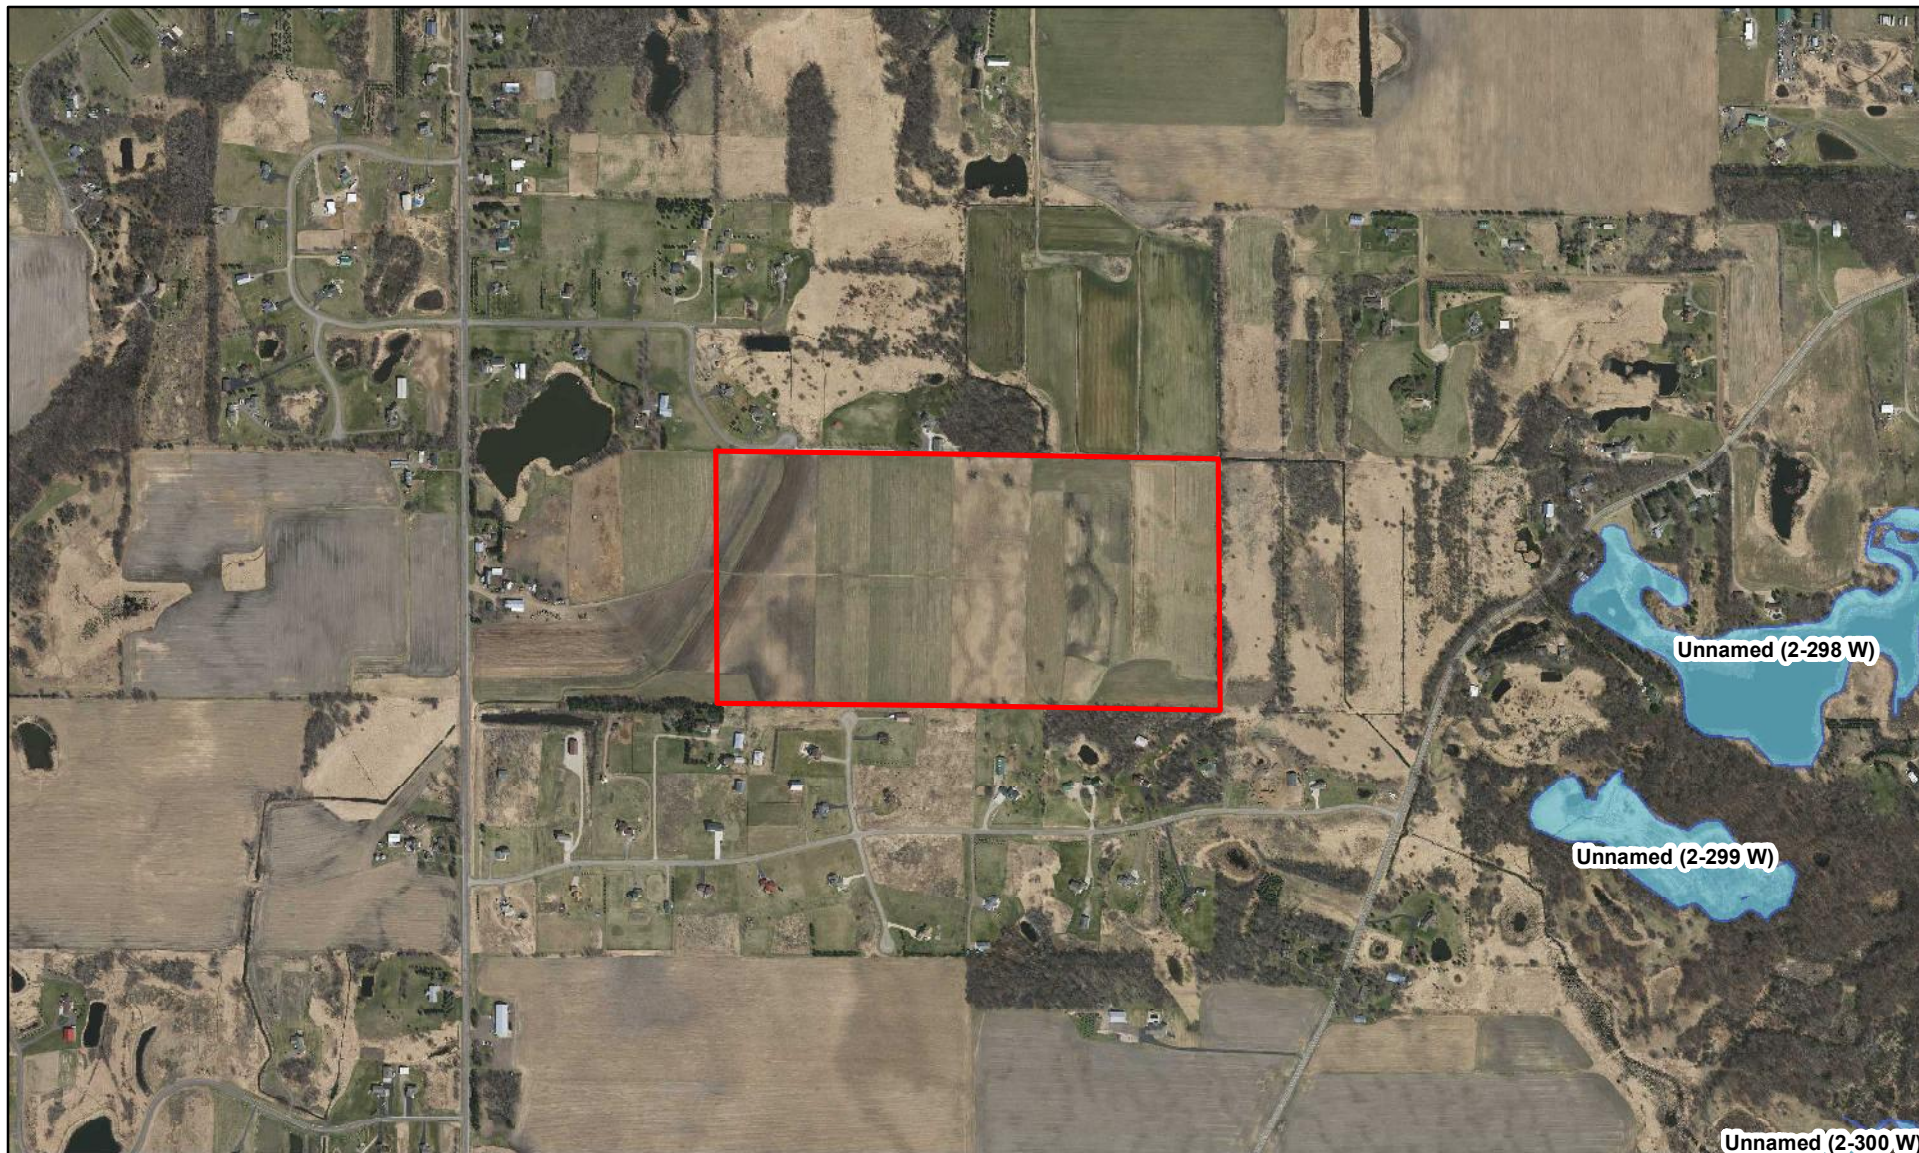
Figure 5 - DNR Public Waters Inventory

The [Minnesota DNR Public Waters Inventory](#) (Minnesota Department of Natural Resources 2015) showed no DNR Public Waters, Wetlands or Waterways within 1000 feet of the site (**Figure 5**).
